H0420

Programmable MP3-player for scale models, broadcast systems and special applications

Firmware Update: Version 1.10 Build 4613

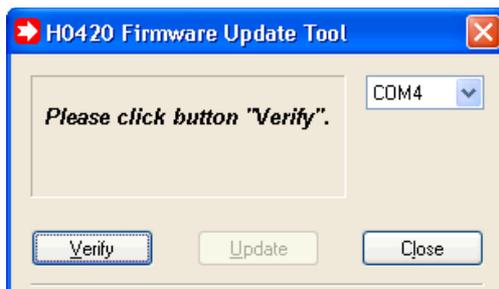
Locate the “Firmware Update Tool” in the *Start Menu* (under *Programs / H0420 MP3 Controller*), and run it —this tool was installed in step 1. See the screen shot below for the appearance of the Firmware Update Tool.

Make sure that the correct COM port (RS232) is selected in the update tool.

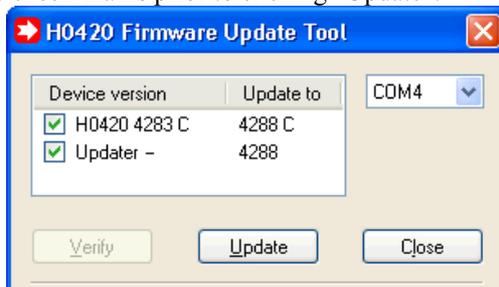
If “Verify” completed successfully, it will present you with a list of firmware components that has found in the device and what updates are available. There may be 1,2 or 3 items in the list. If the Firmware Update Tool proposes that a component must be updated, it has placed a check-mark on the row; if the Firmware Update Tool detects that the device already has an up-to-date component, it will remove the check-mark from the row. You can overrule the proposed updates by toggling the check-marks prior to clicking “Update”.

The revision/build numbers in the screen shots may differ from the ones that you are seeing. For example, the “Update to” value for the H0420 firmware will be 4299 for the current firmware release.

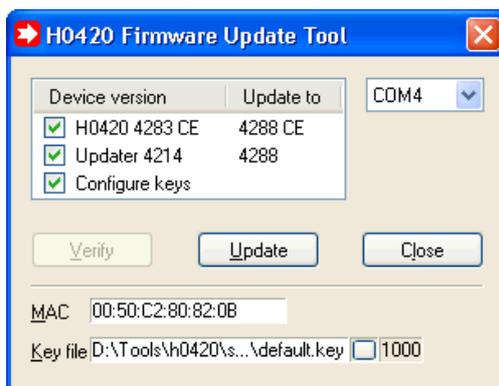
If you have a custom key file (for encrypted MP3 tracks or encrypted CompactFlash cards), or if you have an Ethernet extension board for the H0420, the Firmware Update Tool shows up to two additional rows with entry fields: one for the MAC address and one for a key file. You may need to adjust the MAC address, with one that was provided with the network extension board.

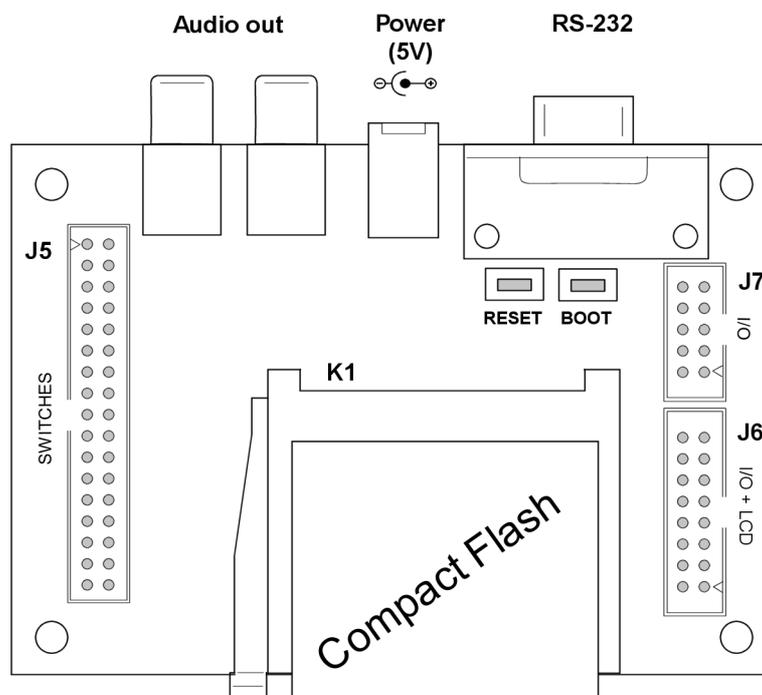
The H0420 has two switches, behind the connector of the RS232. In order to gain access to these switches, it may be necessary that you open the case in which the H0420 is mounted.

These switches must be pressed and released in the correct order:

- Press (and hold) “**RESET**”
- Press (and hold) “**BOOT**”
- Release “**RESET**”
- Release “**BOOT**”

If this fails again, try to reset the H0420 while the Update Tool is busy verifying the device. That is: click on the button “Verify” and then press the “**RESET**” switch on the H0420. See below for the location of the reset button. You may also want to try to perform the procedure after rebooting the PC, or from a different PC.
